PHOTOGRAPHIC SURVEY OF THE LDEF MISSION

NASA Special Publication 531

Robert L. O'Neal

National Aeronautics and
Space Administration

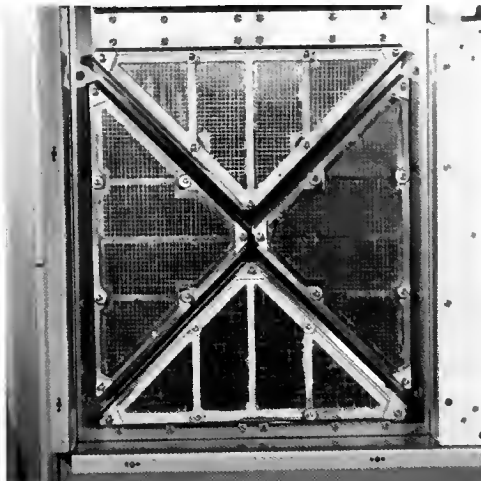
Figure 256
Photo No.: KSC-390C-1538.02
Dup. Neg. No.: L91-8840
LISAR No.: EL-1994-00692
Photo Credit: KSC
Photo Date: 3/2/90
Location: KSC SAEF II
Subject: Postflight Detail of Lower Left of Tray C9

Figure 256 (Postflight). This photograph is of the lower left one-sixth of the tray. The mesh support, the detector foils, and the bond joints show no sign of physical failure. There are some darker contamination stains in areas on the die-cast aluminum frames where adhesive residue remained after preflight cleaning.

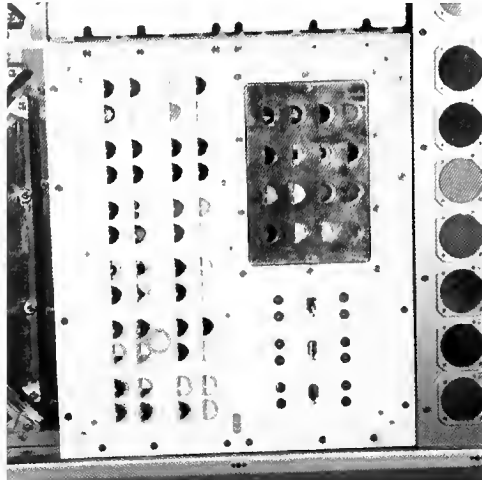
Figure 257
Photo No.: KSC-390C-1538.03
Dup. Neg. No.: L91-8841
LISAR No.: EL-1994-00693
Photo Credit: KSC
Photo Date: 3/2/90
Location: KSC SAEF II
Subject: Postflight Detail of Lower Part of Tray C9

Figure 257 (Postflight). This photograph is of the lower one-sixth of the tray. Experiment AO114 shows a little change in the color of the white paint. A very faint tan tint exists around the outside edges of the cover plate and the outside ring of fasteners. The material specimens remain intact in their mountings and seem to have survived well the exposure to the space environment. The polished aluminum cover plate has darkened and seems to have a duller finish than in the preflight photograph.

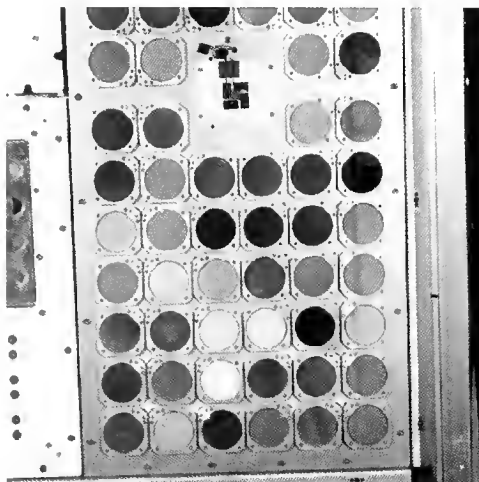
Figure 258
Photo No.: KSC-390C-1538.04
Dup. Neg. No.: L91-8842
LISAR No.: EL-1994-00694
Photo Credit: KSC
Photo Date: 3/2/90
Location: KSC SAEF II
Subject: Postflight Detail of Lower Right of Tray C9

Figure 258 (Postflight). This photograph is of the lower right one-sixth of the tray. Close inspection of the photograph reveals several locations where impacts on detector surfaces are visible. A faint gold or tan stain is visible around several fasteners and in a rectangular configuration near the center along the bottom edge of the detector mounting plate. Stains are also visible near the top right edge of the solar sensor, on the mounting plate, and around the extreme edges of the solar sensor baseplate. The colors and designs on the detectors are reflections of the surrounding area.

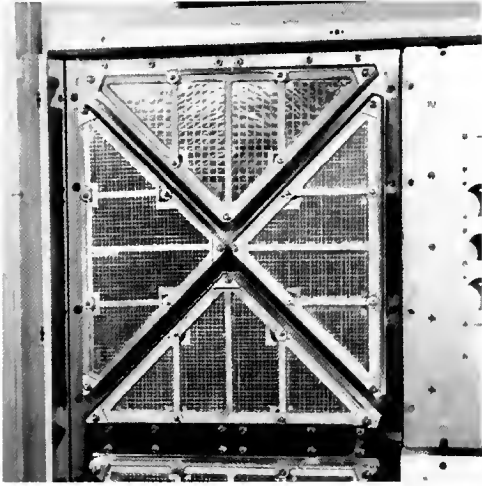
Figure 259 (Postflight). This photograph is of the upper left one-sixth of the tray. The sensor foils are intact, but some areas of the mounting frames appear discolored.

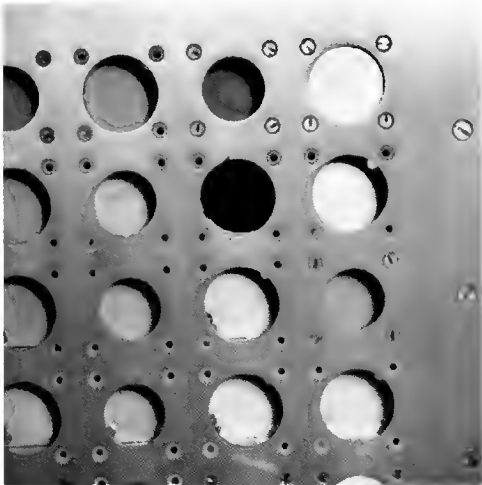
Figure 260 (Postflight). This close-up is of a portion of the upper center one-sixth of the tray. The test specimens appear intact. Some shadows appear on some of the recessed test specimens.

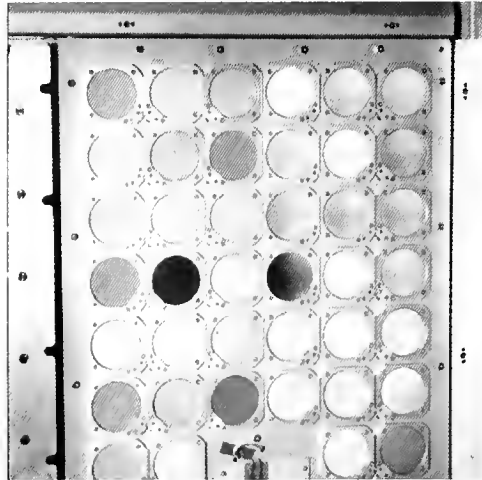
Figure 261 (Postflight). This close-up is of the upper right one-sixth of the tray. The impact sensors are intact. The different colors are reflections of the surrounding area. Evidence of space debris impacts are visible on some of the lighter colored sensors. Some light discoloration is visible around the baseplate fasteners.

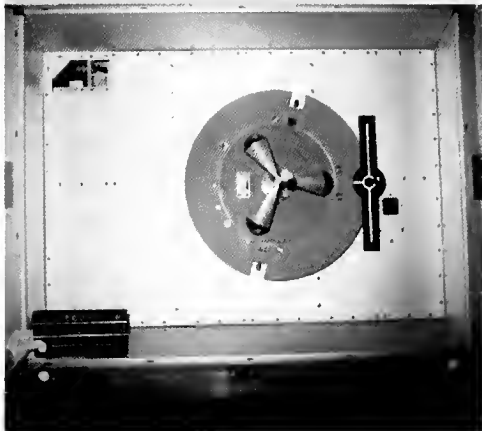
Figure 262 (Preflight). The tray assembly consisted of a modified 6-in-deep peripheral experiment tray, a chromic-anodized aluminum mounting plate with chamfered corners, an initiate switch assembly, an initiate system status indicator assembly, nonmagnetic stainless steel fasteners, and a modified mechanical grapple fixture that was provided by JSC with a camera target attached. The camera target, which was black with white markings, was attached to the right edge of the grapple fixture and assisted the operator in positioning the RMS end effector. The opening in the upper left corner of the mounting plate provided access to the initiate system activation connectors and was covered by an aluminum plate prior to installing the LDEF in the cargo bay of the orbiter. The black square in the right center of the mounting plate adjacent to the camera target, is the initiate system status indicator assembly. Scratch marks from preassembly activities are visible on the lower right corner and on the upper left corner slightly below the access opening of the grapple fixture mounting plate.

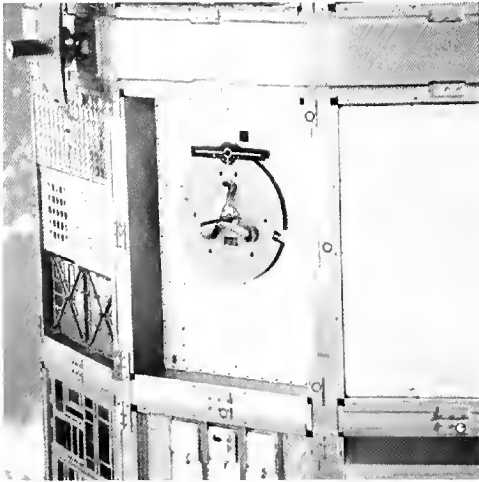
Figure 263
Photo No.: S32-78-073
Dup. Neg. No.: L90-10443
LISAR No.: EL-1994-00016
Photo Credit: JSC
Photo Date: 1/12/90
Location: In Flight
Subject: In-Flight Survey of Tray C10

Figure 263 (In Flight). The grapple tray assembly appears to be without physical damage. The color of the tray and surrounding areas of the LDEF have a somewhat unrealistic pink or orange cast. The dark gray circular discolorations on the outer section of the grapple fixture appear to be the locations of impact craters where the surrounding surface coating has been disturbed.

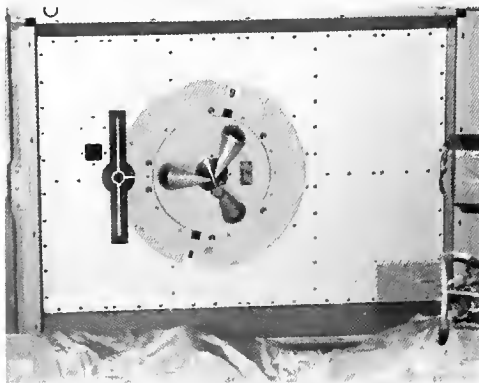
Figure 264
Photo No.: KSC-390C-612.03
Dup. Neg. No.: L92-17794
LISAR No.: EL-1994-00161
Photo Credit: KSC
Photo Date: 1/30/90
Location: KSC OPF
Subject: Postflight Survey of Tray C10

Figure 264 (Postflight). The grapple tray assembly is without physical damage. The chromic anodized aluminum mounting plate is in prelaunch condition with only a very light tan discoloration. The aluminum cover plate located in the lower right corner of the tray has a number of irregular darker discolorations around the outer edges that appear to be fingerprints. The dark gray circular discolorations on the outer section of the grapple fixture are impact craters where the surrounding surface coating has been disturbed.

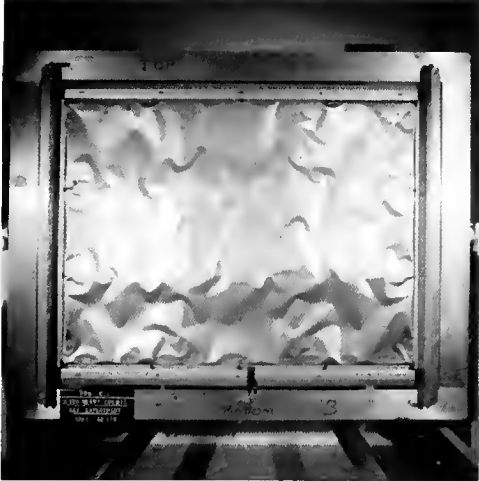
Figure 266 (In Flight). The thermal cover surface appears to have changed from specular to opaque. There are indications of a number of impacts on or penetrations of the thermal cover. The cover is more taut than in the prelaunch photograph and the locations of Velcro attachment pads are apparent. The ground strap is in place with no visible damage, but it is a darker color.

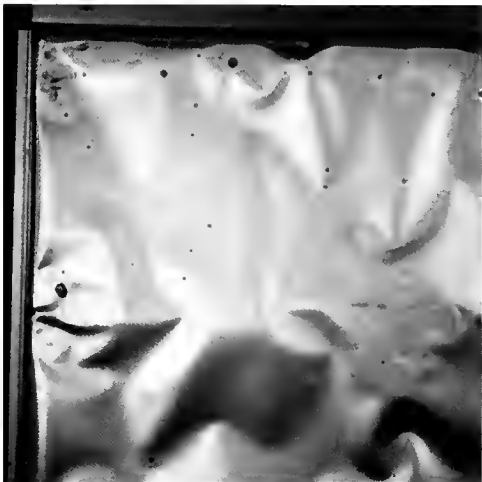
Figure 267
Photo No.: KSC-390C-2109.09
Dup. Neg. No.: L91-9372
LISAR No.: EL-1994-00299
Photo Credit: KSC
Photo Date: 3/20/90
Location: KSC SAEF II
Subject: Postflight Survey of Tray C11

Figure 267 (Postflight). The thermal cover surface appears to have changed from specular to opaque with many black dots of various sizes that indicate impacts on or penetrations of the thermal cover. Photographic light reflections wash out many of the details. The cover is not as taut as in the in-flight photograph and locations of Velcro attachment pads are not as prominent. The ground strap is in place with no visible damage, but it is a deeper copper color.

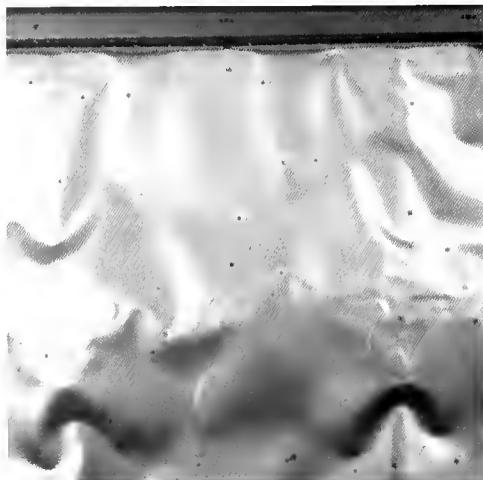
Figure 268
Photo No.: KSC-390C-2109.10
Dup. Neg. No.: L91-9373
LISAR No.: EL-1994-00484
Photo Credit: KSC
Photo Date: 3/20/90
Location: KSC SAEF II
Subject: Postflight Detail of Upper Left of Tray C11

Figure 268 (Postflight). This photograph is of the upper left one-sixth of the tray. The thermal cover appears opaque rather than specular as it was in preflight photographs. The numerous discolorations indicate impacts on or penetrations of the thermal cover. The Velcro thermal cover attachment pads are evident.

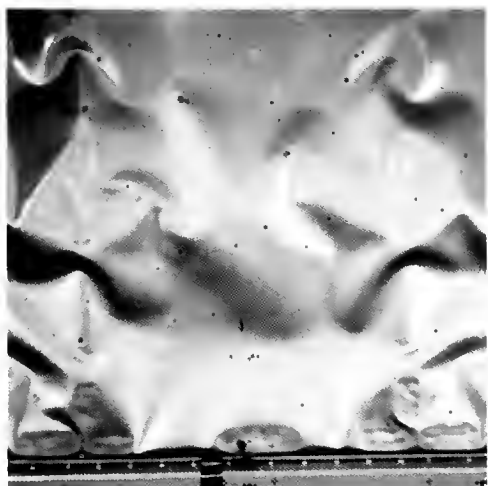
Figure 271
Photo No.: KSC-390C-2111.05
Dup. Neg. No.: L92-17087
LISAR No.: EL-1994-00487
Photo Credit: KSC
Photo Date: 3/20/90
Location: KSC SAEF II
Subject: Postflight Detail of Lower Left of Tray C11

Figure 271 (Postflight). This photograph is of the lower left one-sixth of the tray. The thermal cover appears opaque rather than specular as it was in preflight photographs. The numerous discolorations indicate impacts on or penetrations of the thermal cover. The Velcro thermal cover attachment pads are evident.

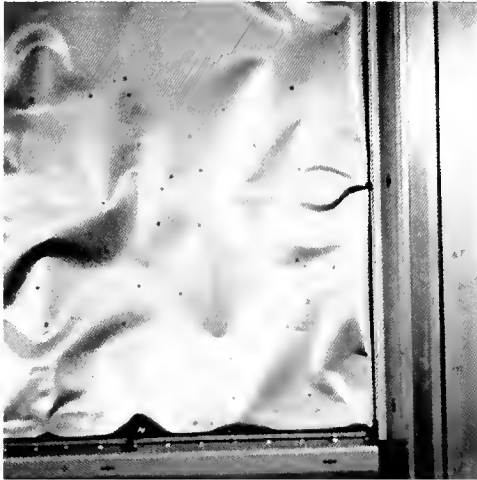
Figure 272
Photo No.: KSC 390C-2111.06
Dup. Neg. No.: L92-17088
LISAR No.: EL-1994-00488
Photo Credit: KSC
Photo Date: 3/20/90
Location: KSC SAEF II
Subject: Postflight Detail of Lower Center of
Tray C11

Figure 272 (Postflight). This photograph is of the lower center one-sixth of the tray. The thermal cover appears opaque rather than specular as it was in preflight photographs. The numerous discolorations indicate impacts on or penetrations of the thermal cover. The Velcro thermal cover attachment pads are evident.

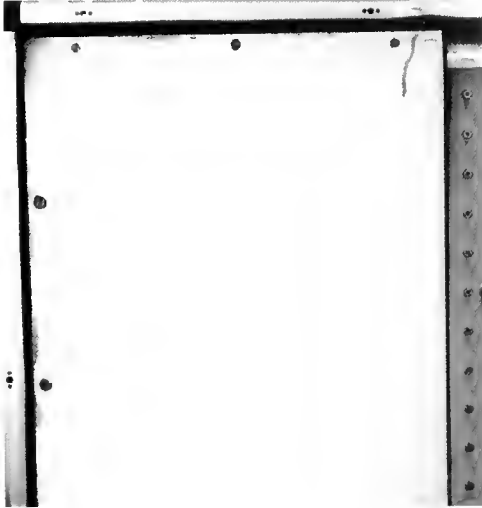
Figure 277
 Photo No.: KSC-390C-2204.02
 Dup. Neg. No.: L91-9317
 LISAR No.: EL-1994-00300
 Photo Credit: KSC
 Photo Date: 3/22/90
 Location: KSC SAEF II
 Subject: Postflight Survey of Tray C12

Figure 277 (Postflight). The colors of two coils of the externally mounted fiber optic cables have changed significantly from preflight. Four dark brown areas of discoloration are visible around the openings to the tray interior; these openings are located in the vertical seam between the mounting plates. Dark brown irregular discolorations are also visible along the vertical and upper edges of the cover plate. An irregular vertical stain (not observed in the in-flight photograph) on the upper right corner of the cover plate is now visible.

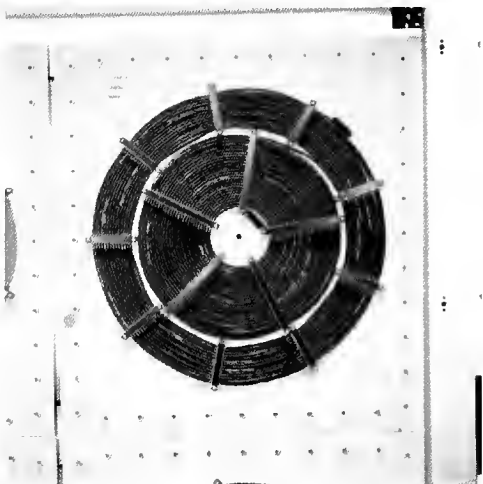
Figure 279 (Postflight). This photograph is of the upper center one-sixth of the tray. The cable has changed from a light blue to a blue gray. The color of the silicone-rubber spacers under the coil attachment clips have changed from clear to brown and have discolored the fiber coils in areas adjacent to the spacers. A flow pattern of discoloration appears to extend downward from fasteners used to secure the four mounting plates.

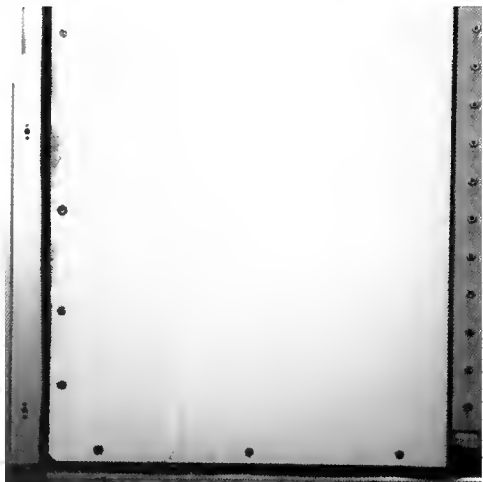
Figure 281 (Postflight). This photograph is of the lower left one-sixth of the tray. The cover without cable has extensive brown contamination along the left edge. There is also a flow pattern extending up from the bottom edge.

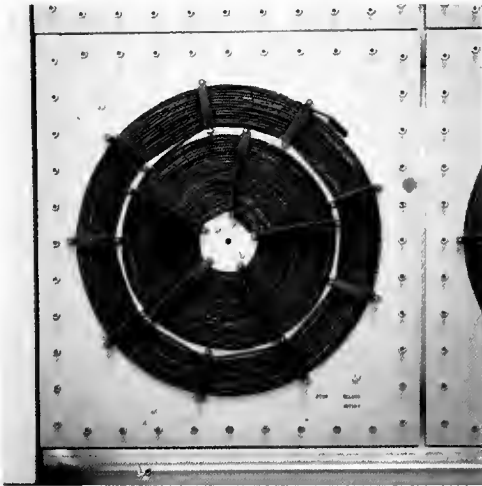
Figure 282 (Postflight). This photograph is of the lower center one-sixth of the tray. The silicone-rubber spacers under the coil attachment clips have changed from clear to brown and have discolored the fiber coils in areas adjacent to the spacers. A flow pattern of discoloration appears to extend downward from fasteners used to secure the four mounting plates.

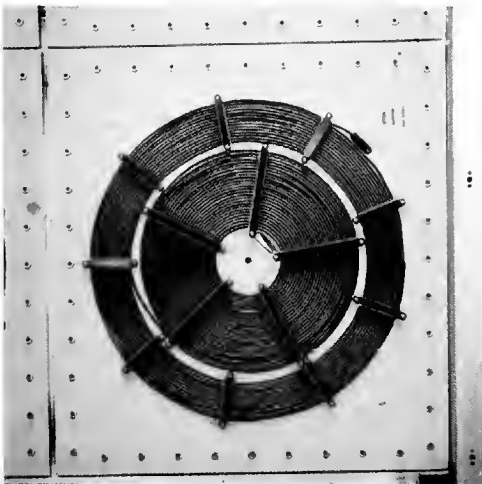
Figure 283 (Postflight). This photograph is of the lower right one-sixth of the tray. The cable, originally a bright orange, is dark brown. The silicone-rubber spacers under the coil attachment clips have changed from clear to brown and have discolored the fiber coils in areas adjacent to the spacers. A flow pattern of discoloration appears to extend downward from fasteners used to secure the four mounting plates.

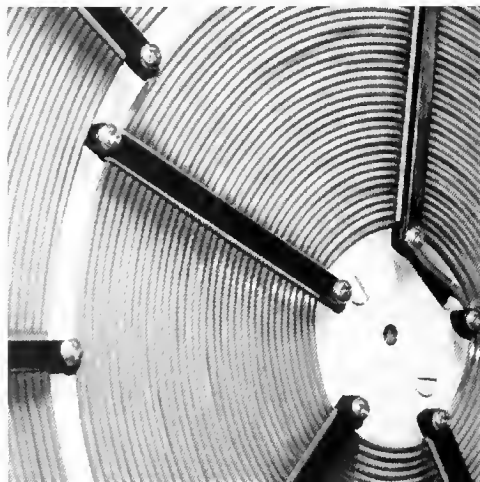
Figure 285 (Postflight). This close-up photograph is of the upper center coil, which shows the silicone-rubber spacers under the coil attachment clips. The spacers have changed from clear to brown and have discolored the fiber coils in areas adjacent spacers.

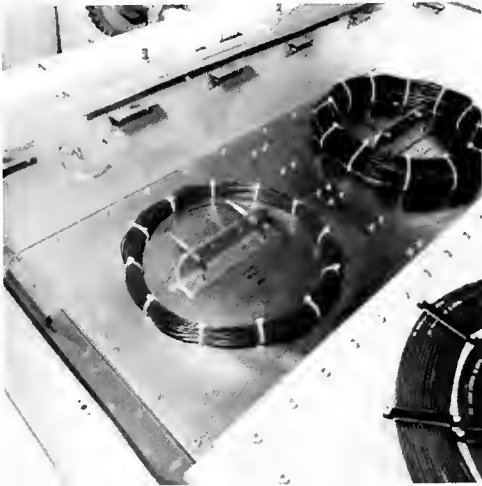
Figure 286 (Postflight). This photograph is of the area beneath the cover without cable. The far side wall and the bottom of the tray appeared wet with brown contamination along the cover edges.

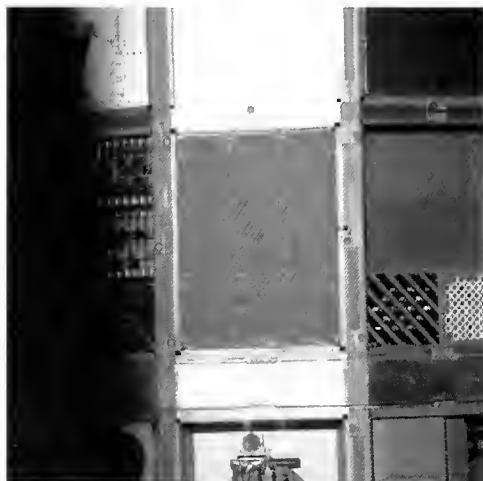
Figure 287 (In Flight). The thermal cover appears to be without physical damage, but it is more taut than in the prelaunch photograph. The glossy blue appearance of the thermal cover in this photograph is apparently caused by the lighting conditions and not by a change in the material optical properties. A few white dots and circular indentations are probably impact on or penetrations of the thermal cover. Velcro attachment pads are evident.

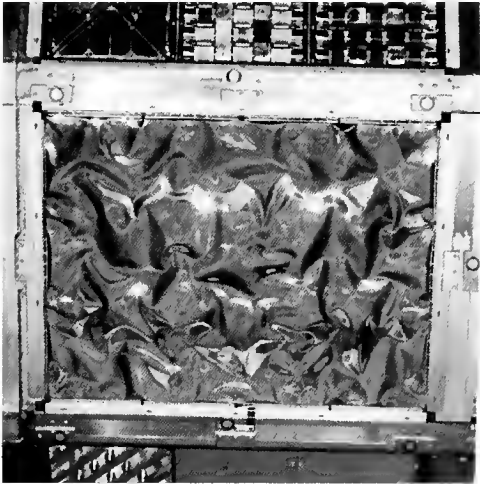
Figure 288 (Postflight). The thermal cover appears specular and no change from in-flight condition is indicated. The bright irregular discoloration located above the grounding strap at about one-third of the height of the thermal cover from the bottom edge did not appear in the in-flight photograph. The discoloration appears to be a piece of material from a degraded experiment that has become attached to the cover. The cover has numerous white dots that may also be debris from other degraded experiments. The cover is less taut than in the in-flight photograph, but the locations of the Velcro attachment pads are still evident.

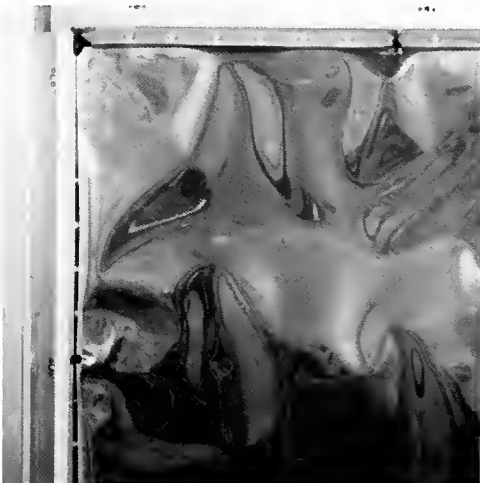
Figure 289 (Postflight). This photograph is of the upper left one-sixth of the tray. The thermal cover appears specular with no apparent damage. The reflective properties of the uneven surface of the cover result in various light and color patterns. The locations of the Velcro attachment pads are obvious. A few impact or penetration discolorations and small debris from nearby degraded experiments are visible.

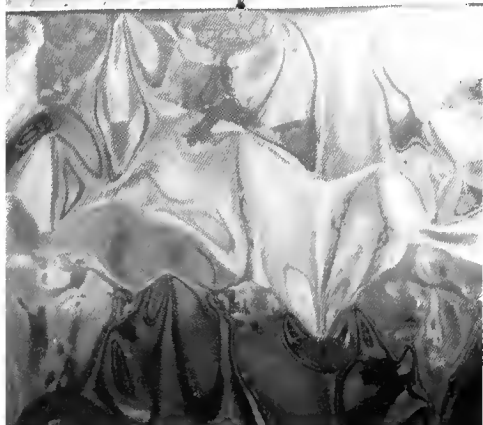
Figure 290 (Postflight). This photograph is of the upper center one-sixth of the tray. The thermal cover appears specular with no apparent damage. The reflective properties of the uneven surface of the cover result in various light and color patterns. The locations of the Velcro attachment pads are obvious. A few impact or penetration discolorations and small debris from nearby degraded experiments are visible.

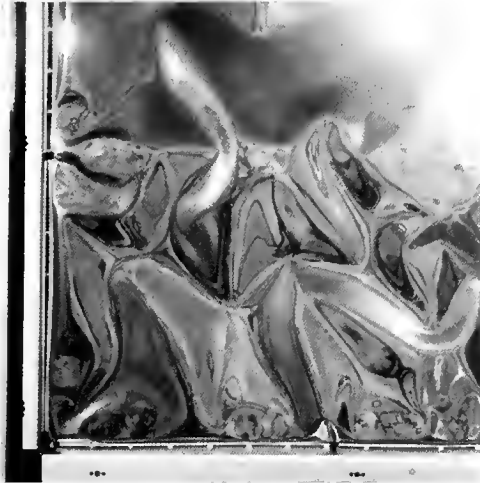
Figure 292 (Postflight). This photograph is of the lower left one-sixth of the tray. The thermal cover appears specular with no apparent damage. The reflective properties of the uneven surface of the cover result in various light and color patterns. The locations of the Velcro attachment pads are obvious. A few impact or penetration discolorations and small debris from nearby degraded experiments are visible.

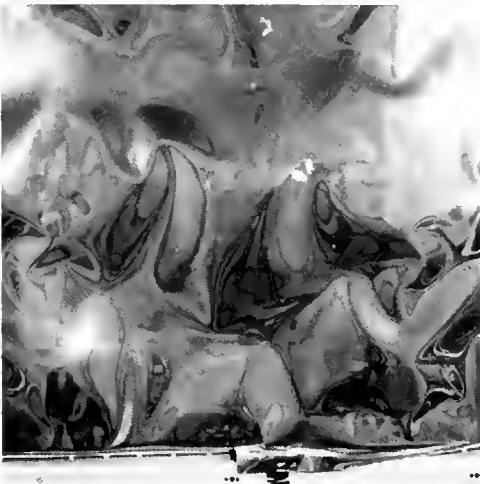
Figure 293 (Postflight). This photograph is of the lower center one-sixth of the tray. The thermal cover appears specular. The tear in the lower center of the cover occurred during tray removal. The reflective properties of the uneven surface of the cover result in various light and color patterns. The locations of the Velcro attachment pads are obvious. A few impact or penetration discolorations and small debris from nearby degraded experiments are visible.

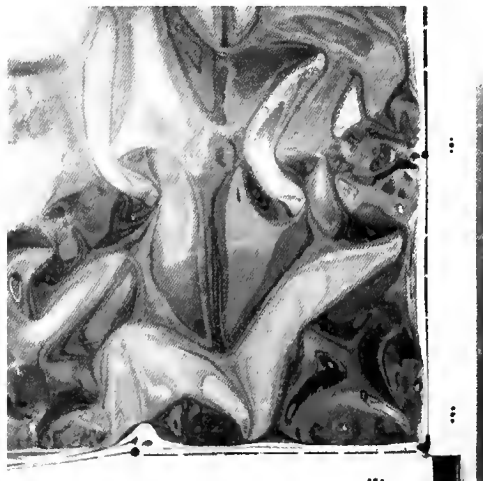
Figure 294 (Postflight). This photograph is of the lower right one-sixth of the tray. The thermal cover appears specular with no apparent damage. The reflective properties of the uneven surface of the cover result in various light and color patterns. The locations of the Velcro attachment pads are obvious. A few impact or penetration discolorations and small debris from nearby degraded experiments are visible.

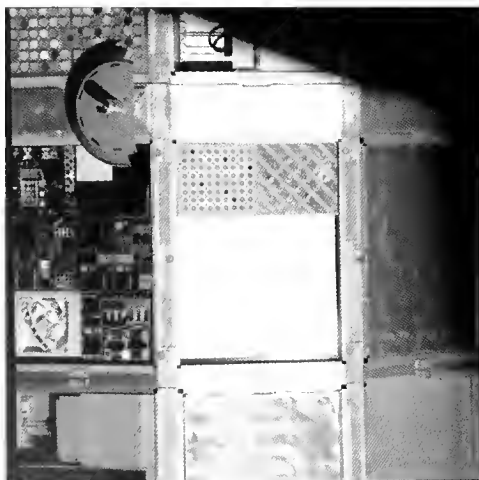
Figure 296 (In Flight). The aluminum mounting plate of experiment AO172, which was painted with Chemglaze II A-276 white paint, is now a uniform brown as are the diagonal stripes on experiment AO189. Light reflections appear on the unpainted stripes of experiment AO189. Reflected light obscures any color definition of the panels of experiment S0001.

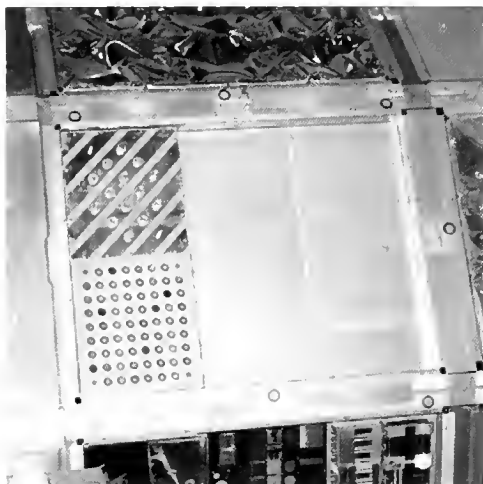
Figure 297 (Postflight). The surfaces of experiments AO172 and AO189 that were painted with Chemglaze II A-276 white paint are now a uniformly discolored tan. The faint patterns in experiment S0001 panels were observed in preflight.

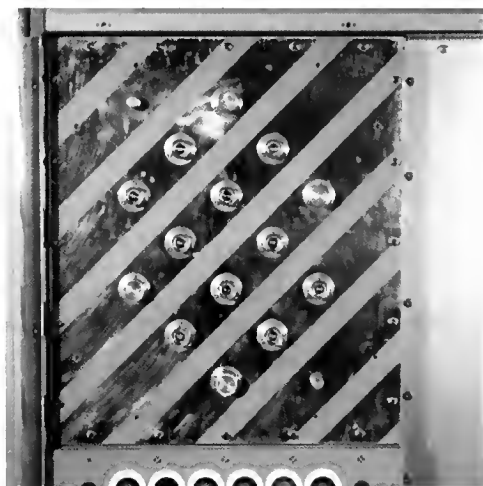
Figure 298 (Postflight). This photograph is of the upper left one-sixth of the tray. The sensors appear undamaged, but the paint strips that were white before flight are now tan. Light reflections make imperfections in the surface finish that existed before flight more visible.

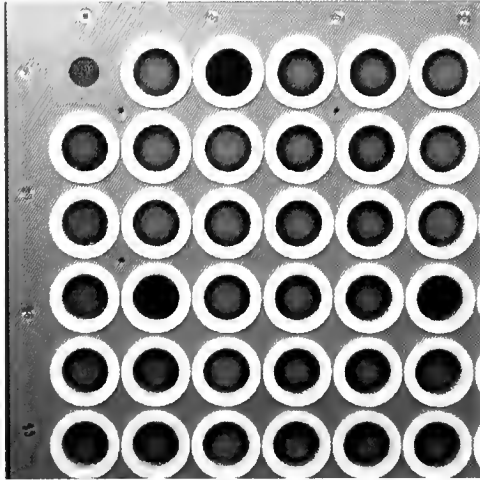
Figure 299 (Postflight). This photograph is of the lower left one-sixth of the tray. The sensors appear undamaged, but the white paint on the baseplate is now tan.

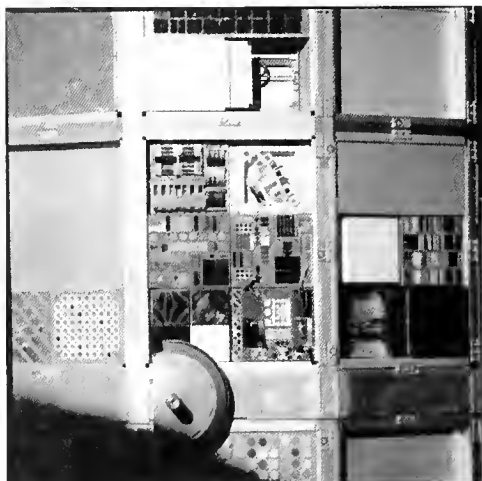
Figure 301 (In Flight). Experiment M0003 appears to be in good condition except that approximately half of the thin-film polymers in the lower right tray section are loose at one end. Other material samples seem intact, but they appear discolored. Experiment M0002-1 appears to be without physical damage, but it has a light tan discoloration on the detector housings and the surfaces of the experiment support structure.

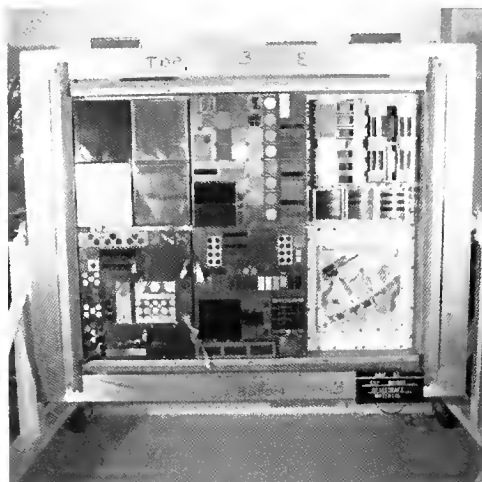
Figure 302 (Postflight). No significant differences from in-flight conditions are apparent. Many experiment specimens and mounting hardware are discolored. The damaged thin-film polymers in the lower left are still attached. Other parts of the experiments appear intact.

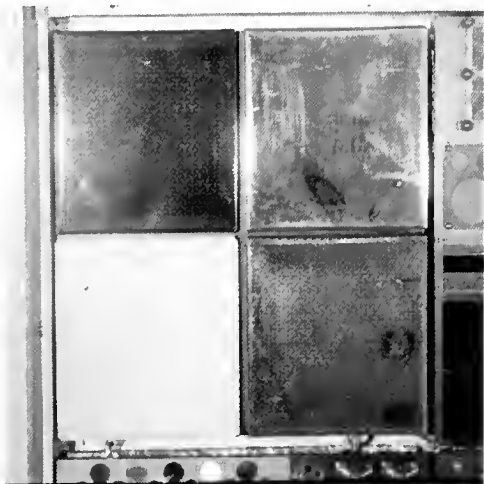
Figure 303 (Postflight). This photograph is of the upper left one-sixth of the tray. The metallized and coated polymers appear to have survived the exposure intact, but discolorations are apparent.

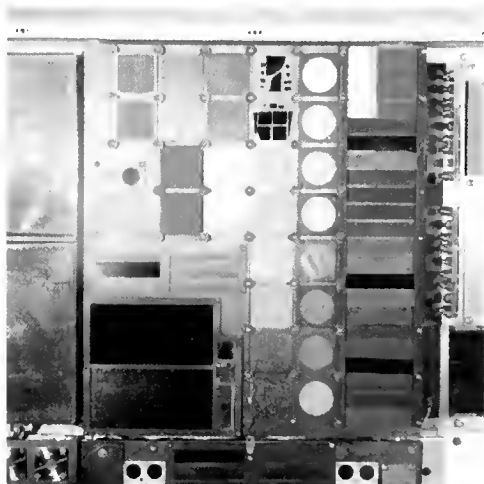
Figure 304 (Postflight). This photograph is of the upper center one-sixth of the tray. Most test specimens appear intact, but there appears to be significant brown discoloration on specimens and specimen mounting hardware. Composite material samples located in upper right, upper center, and lower center remain intact, but they are bleached or discolored.

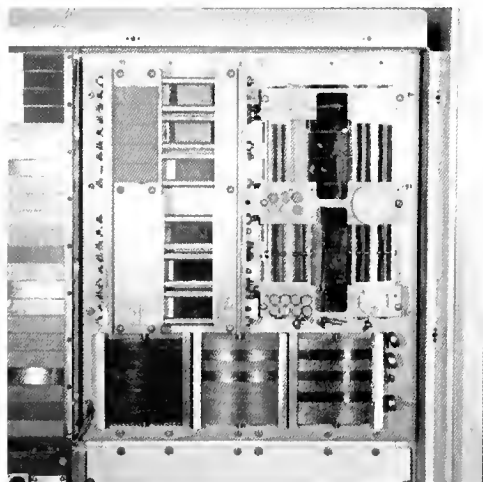
Figure 305 (Postflight). This photograph is of the upper right one-sixth of the tray. Most test specimens appear intact, but there seems to be significant brown discoloration on specimens and specimen mounting hardware. Composite material samples located in upper right, upper center, and lower center remain intact, but they are bleached or discolored.

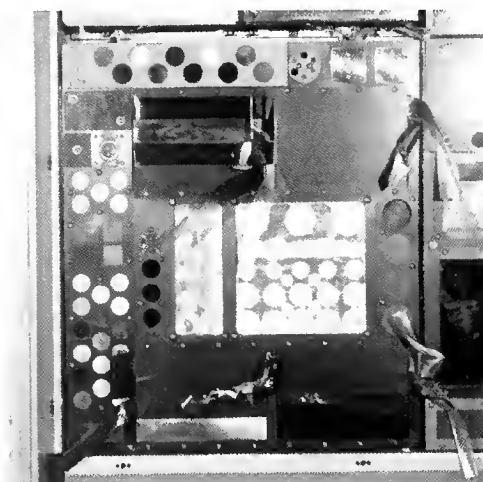
Figure 306 (Postflight). This photograph is of the lower left one-sixth of the tray. Many of the thin-film polymers are loose at one end. The Teflon covers and the large square and the rectangle in the center appear to remain intact; however, they have changed from silver to milky white where components are located beneath them and to a gold color where there are no components. Surfaces and mounting hardware appear to have significant brown discoloration.

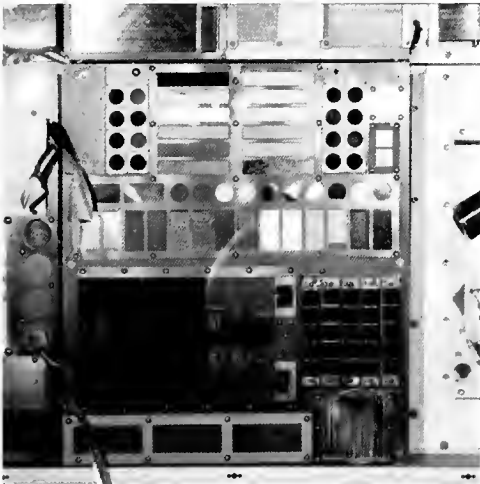
Figure 307 (Postflight). This photograph is of the lower center one-sixth of the tray. Most test samples appear intact, but samples and mounting hardware have extensive discolorations. Composite material samples that are located in the upper right, the upper center, and the lower center remain intact, but they are bleached or discolored.

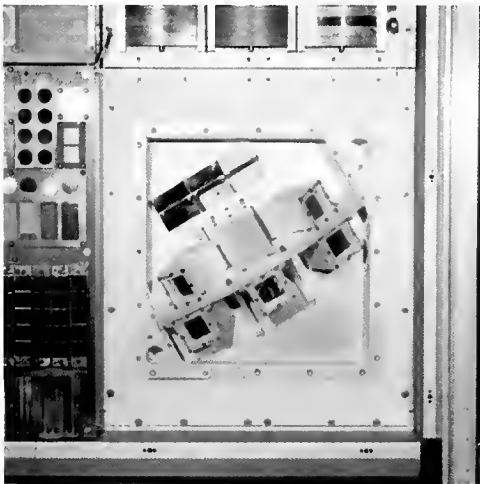
Figure 308 (Postflight). Experiment M0002-1 in the lower right one-sixth of the tray appears intact, but it is a somewhat uniform tan rather than white, which was the color it was painted before flight.

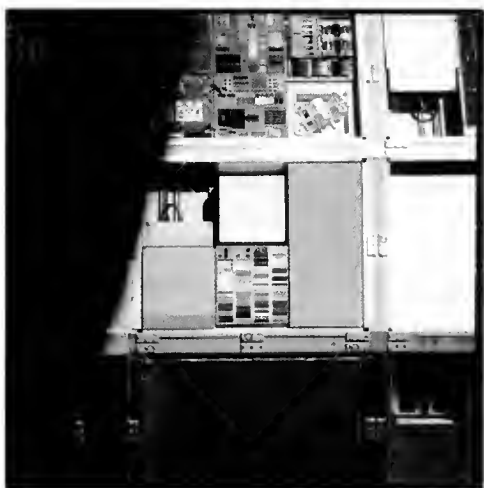
Figure 310
Photo No.: S32-89-004
Dup. Neg. No.: L90-10493
LISAR No.: EL-1994-00128
Photo Credit: JSC
Photo Date: 1/12/90
location: In Flight
Subject: In-Flight Survey of Tray D4

Figure 310 (In Flight). The Chemglaze II A-276 white paint on the EPDS cover has changed to a medium brown and the IITRI S13G-LO white paint has become light tan or off-white. Colors of the composite material samples are bright and clear. Some material samples appear to be blue in this photograph, although they did not in prelaunch or postflight photographs. The mounting plate of the composite materials experiment has discolorations that vary from a light tan to a medium brown. The rectangular aluminum cover plate located in the upper center of the experiment is a uniform light brown. The thermal covers on the EECC appear to have changed to lavender or purple in this photograph; however the covers maintain the color of anodized aluminum in postflight photos. The dark square discolorations on the upper corners of the thermal cover are pads of tape used to cover exposed sharp corners. The pads were not in place in the prelaunch photograph.

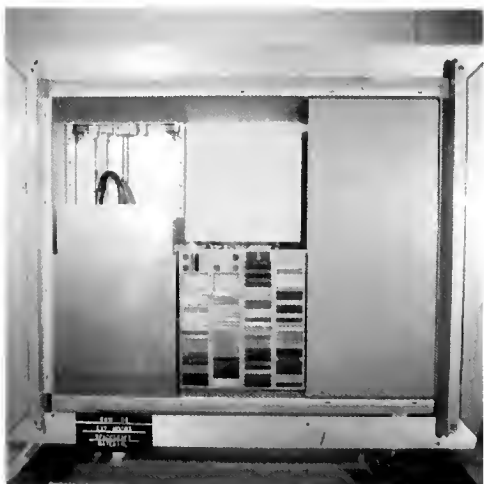
Figure 311
Photo No.: KSC-390C-1478.03
Dup. Neg. No.: L91-9173
LISAR No.: EL-1994-00202
Photo Credit: KSC
Photo Date: 2/28/90
Location: KSC SAEF II
Subject: Postflight Survey of Tray D4

Figure 311 (Postflight). Light reflections cause details to be less clear than in the in-flight photograph. The painted covers are discolored and the composite materials experiment mounting plate has discolorations that vary from light tan to medium brown.

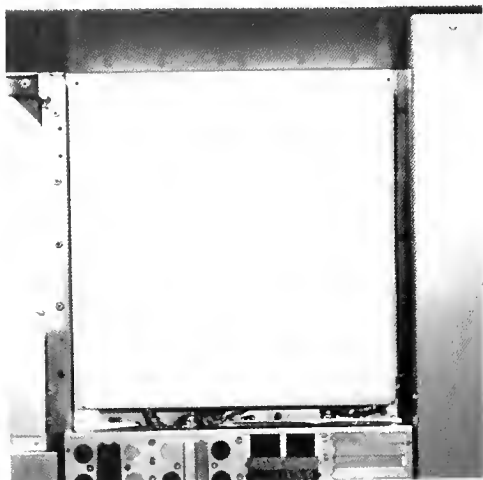
Figure 312 (Postflight). This photograph is of the upper center one-sixth of the tray. The signal conditioning unit thermal cover that was painted with IITRI SI3G-LO white paint has become light tan or off-white.

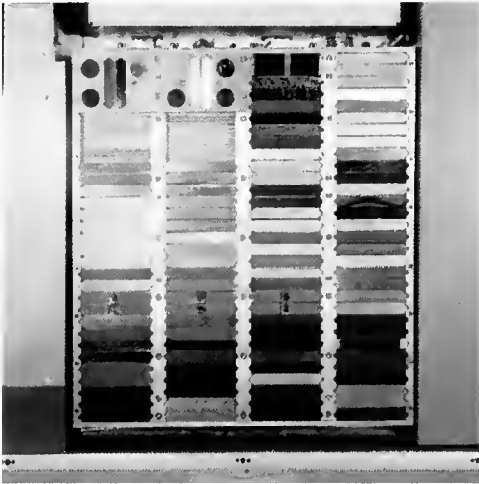
Figure 314
Photo No.: KSC-390C-1478.12
Dup. Neg. No.: L91-9182
LISAR No.: EL-1994-00036
Photo Credit: KSC
Photo Date: 2/28/90
Location: KSC SAEF II
Subject: Postflight Detail of Lower Center of
Tray D4

Figure 314 (Postflight). This photograph is of the lower center one-sixth of the tray. Many test specimens have changed color and some show signs of degradation. Some mounting hardware shows discoloration.

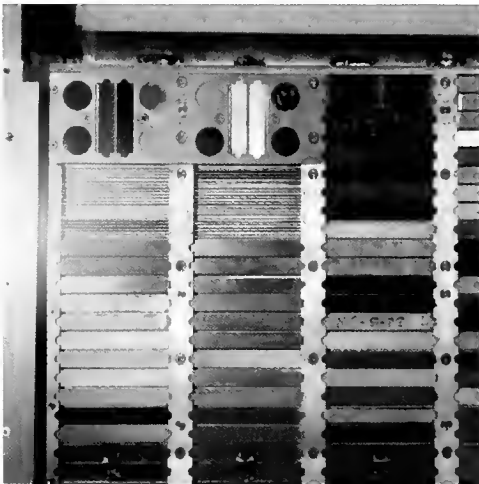
Figure 315
Photo No.: KSC-390C-1480.07
Dup. Neg. No.: L91-9189
LISAR No.: EL-1994-00046
Photo Credit: KSC
Photo Date: 2/28/90
Location: KSC SAEF II
Subject: Postflight Detail of Upper Left of Lower
Center of Tray D4

Figure 315 (Postflight). This close-up photograph is of the upper left of the lower center one-sixth of the tray. Many test specimens have changed color and some show signs of degradation. Some mounting hardware shows discoloration.

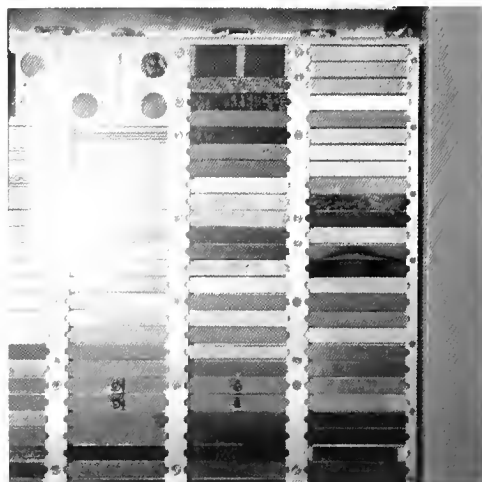
Figure 316 (Postflight). This close-up photograph is of the upper right of the lower center one-sixth of the tray. Many test specimens have changed color and some show signs of degradation. Some mounting hardware shows discoloration. The colors in the upper left area are somewhat washed out because of the lighting.

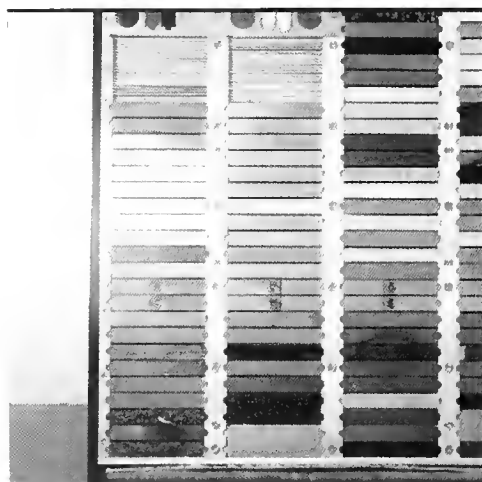
Figure 317 (Postflight). This close-up photograph is of the lower left of the lower center one-sixth of the tray. Many test specimens have changed color and some show signs of degradation. Some mounting hardware shows discoloration.

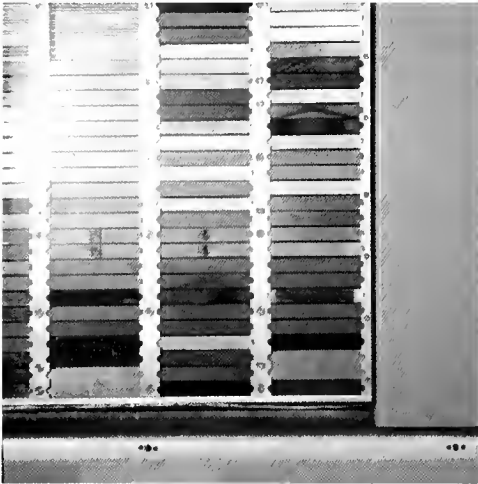
Figure 318 (Postflight). This close-up photograph is of the lower right of the lower center one-sixth of the tray. Many test specimens have changed color and some show signs of degradation. Some mounting hardware shows discoloration.

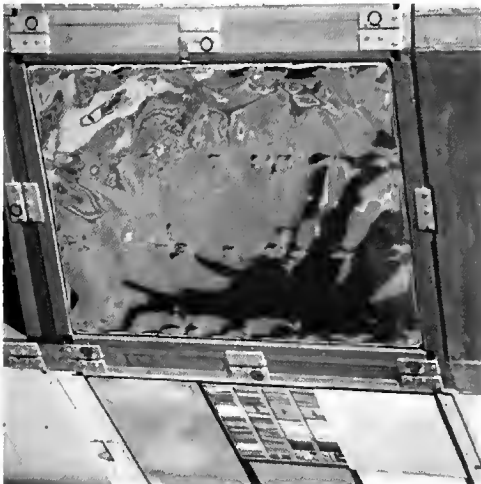
Figure 320
Photo No.: S32-82-017
Dup. Neg. No.: L90-10456
LISAR No.: EL-1994-00038
Photo Credit: JSC
Photo Date: 1/12/90
Location: In Flight
Subject: In-Flight Survey of Tray D5

Figure 320 (In Flight). The thermal cover appears to be without physical damage, but it is more taut than in the prelaunch photograph. The glossy blue-black appearance of the thermal cover in this photograph is due to lighting conditions and not to a change in the material optical properties. The oblong indentations in the thermal cover are in areas where Velcro pads are bonded to the back of the cover. The irregular discolorations on the cover surface are from lighting and reflections. The white dots and the circular indents in the right center of the cover may be impact locations. The ground strap appears to be in place and to have no visible damage.

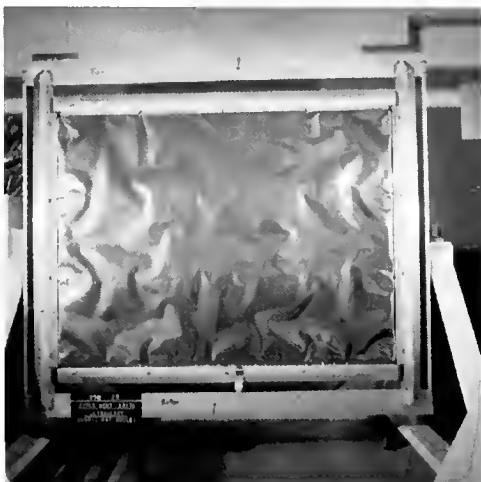
Figure 321
Photo No.: KSC-390C-2277.10
Dup. Neg. No.: L91-10204
LISAR No.: EL-1994-00311
Photo Credit: KSC
Photo Date: 3/23/90
Location: KSC SAEF II
Subject: Postflight Survey of Tray D5

Figure 321 (Postflight). The thermal cover appears specular with no apparent damage. A vertical strip of discoloration that is approximately 6-in. wide with a grainy pattern extends from top to bottom along the left side of the thermal cover. This discoloration was visible prior to flight. The cover appears less taut than in the in-flight photograph and locations of the Velcro attachment pads are not as prominent. The ground strap appears to be in place with no visible damage; however, the color appears darker than in the prelaunch photograph.

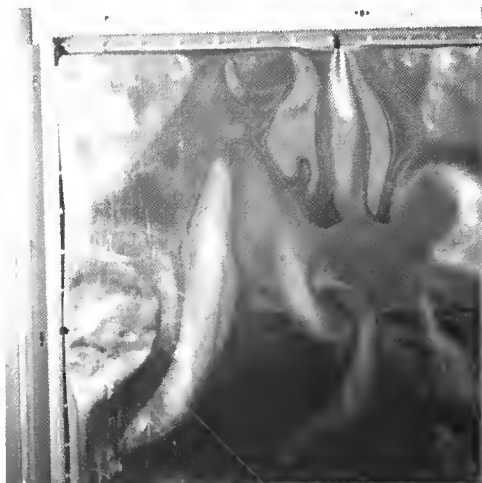
Figure 322 (Postflight). This photograph is of the upper left one-sixth of the tray. The grainy pattern in the surface finish, which is visible in the light reflection was on the material prior to flight. The thermal cover appears specular with no apparent damage. The reflective properties of the uneven surface of the cover result in various light and color patterns. The locations of the Velcro attachment pads are visible.

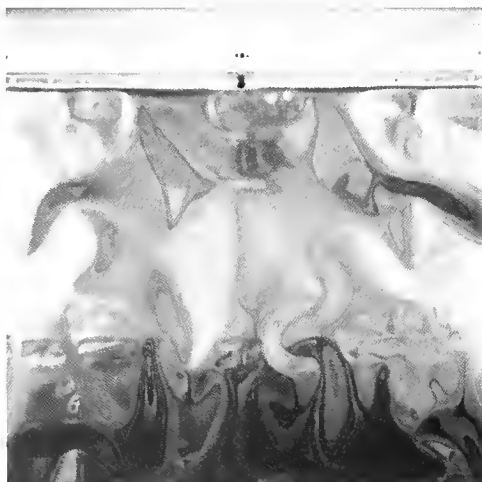
Figure 323 (Postflight). This photograph is of the upper center one-sixth of the tray. The thermal cover appears specular with no apparent damage. The reflective properties of the uneven surface of the cover result in various light and color patterns. The locations of the Velcro attachment pads are visible.

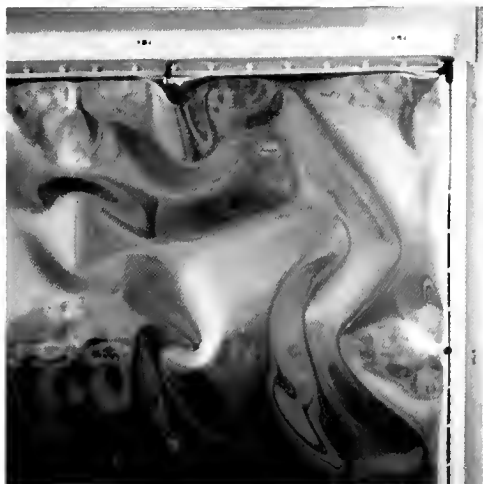
Figure 324
Photo No.: KSC-390C-2279.02
Dup. Neg. No.: L91-10208
LISAR No.: EL-1994-00545
Photo Credit: KSC
Photo Date: 3/23/90
Location: KSC SAEF II
Subject: Postflight Detail of Upper Right of Tray D5

Figure 324 (Postflight). This photograph is of the upper right one-sixth of the tray. The thermal cover appears specular with no apparent damage. The reflective properties of the uneven surface of the cover result in various light and color patterns. The locations of the Velcro attachment pads are visible.

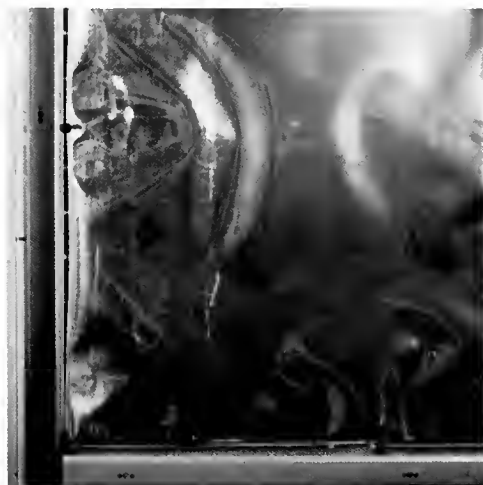
Figure 325
Photo No.: KSC-390C-2279.06
Dup. Neg. No.: L91-10212
LISAR No.: EL-1994-00546
Photo Credit: KSC
Photo Date: 3/23/90
Location: KSC SAEF II
Subject: Postflight Detail of Lower Left of Tray D5

Figure 325 (Postflight). This photograph is of the lower left one-sixth of the tray. The thermal cover appears specular with no apparent damage. The grainy pattern in the surface finish, which is visible in the light reflection, was on the material prior to flight. The reflective properties of the uneven surface of the cover result in various light and color patterns. The locations of the Velcro attachment pads are visible.

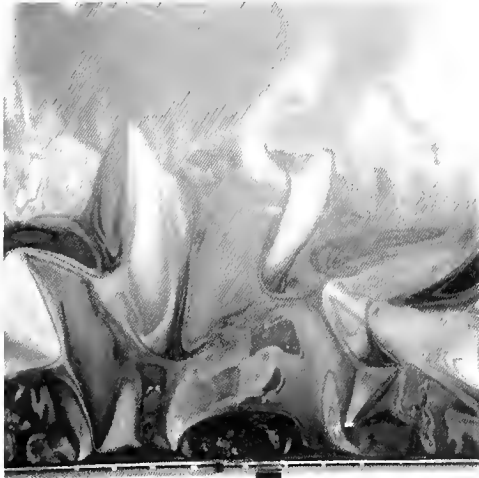
Figure 326
Photo No.: KSC-390C-2279.07
Dup. Neg. No.: L91-10213
LISAR No.: EL-1994-00547
Photo Credit: KSC
Photo Date: 3/23/90
Location: KSC SAEF II
Subject: Postflight Detail of Lower Center of
Tray D5

Figure 326 (Postflight). This photograph is of the lower center one-sixth of the tray. The thermal cover appears specular with no apparent damage. The reflective properties of the uneven surface of the cover result in various light and color patterns. The locations of the Velcro attachment pads are visible.

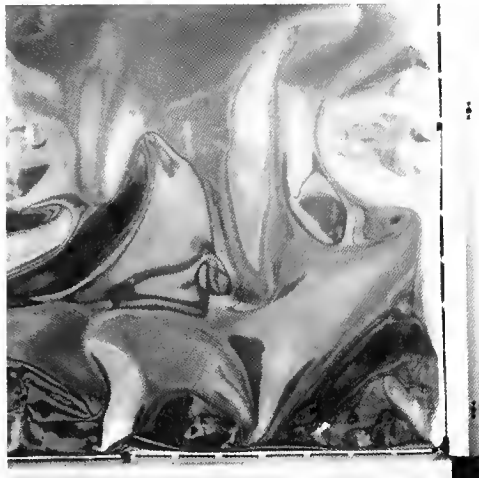
Figure 327
Photo No.: KSC-390C-2279.08
Dup. Neg. No.: L91-10214
LISAR No.: EL-1994-00559
Photo Credit: KSC
Photo Date: 3/23/90
Location: KSC SAEF II
Subject: Postflight Detail of Lower Right of
Tray D5

Figure 327 (Postflight). This photograph is of the lower right one-sixth of the tray. The thermal cover appears specular with no apparent damage. The reflective properties of the uneven surface of the cover result in various light and color patterns. The locations of the Velcro attachment pads are visible.

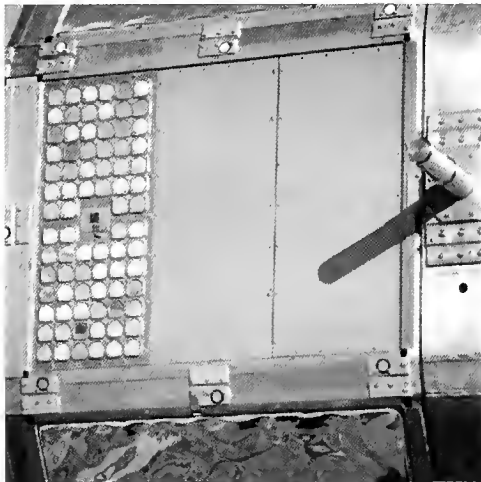
Figure 329 (In Flight). During the mission, the tray surface was at an angle of approximately 82° to the orbital velocity vector, and therefore it was exposed to a higher atomic oxygen flux than if it had been parallel with the velocity vector. Note the difference in color of the paint dots on the tray clampblocks; there are white dots along the top edge, a light tan dot in the center, and dark brown dots along the bottom of the photograph. This color change illustrates the transition from the leading to the trailing sides. Experiment AO201, which is located in the left side of the tray, seems to have a thin coat of the brown contamination stain. The detectors show reflections of the sky and the cargo bay liner in the mirrorlike surfaces. The SDI plates show fingerprints and a palm print that occurred during installation of the panels. These prints are not visible on the preflight photograph.

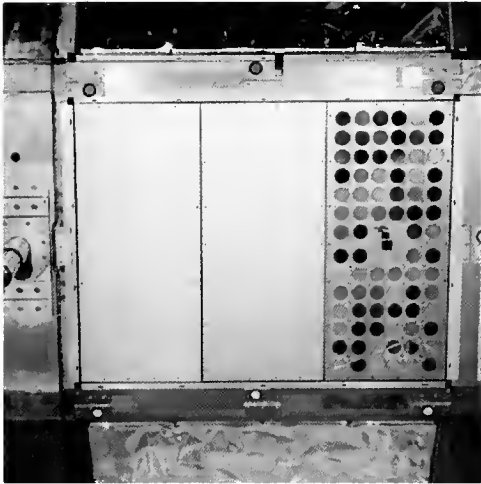
Figure 330
Photo No.: KSC-390C-1033.10
Dup. Neg. No.: L90-13440
LISAR No.: EL-1994-00180
Photo Credit: KSC
Photo Date: 2/9/90
Location: KSC SAEF II
Subject: Postflight Survey of Tray D6

Figure 330 (Postflight). The direction and the intensity of the artificial light source caused reflections that tended to wash out the brown stain on the aluminum structure. Experiment AO201 appears to be in excellent condition in the postflight photograph. All bond joints seem to have survived the space environment and the experiment hardware is intact. The blue in the metallic surface of the detectors is caused by reflections of the surrounding area. The white stripe running diagonally across the bottom two rows of detectors is the reflection of a safety control rope that restricted access to the LDEF.

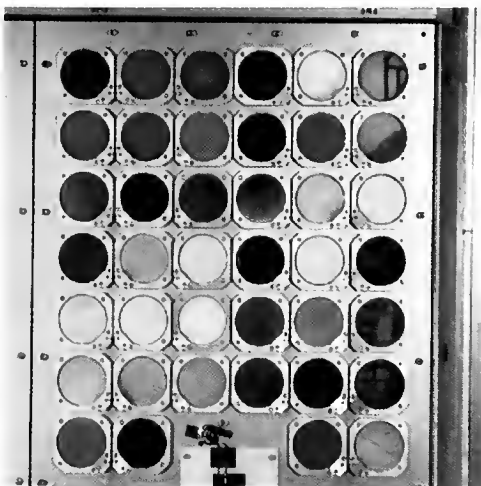
Figure 331
Photo No.: KSC-390C-2070.11
Dup. Neg. No.: L91-10235
LISAR No.: EL-1994-00479
Photo Credit: KSC
Photo Date: 3/19/90
Location: KSC SAEF II
Subject: Postflight Detail of Upper Right of Tray D6

Figure 331 (Postflight). This photograph is of the upper right one-sixth of the tray. The different colors of the detectors are due to reflections of surrounding areas. Some small impacts on the sensors are visible. There is some discoloration of the mounting hardware and the baseplate.

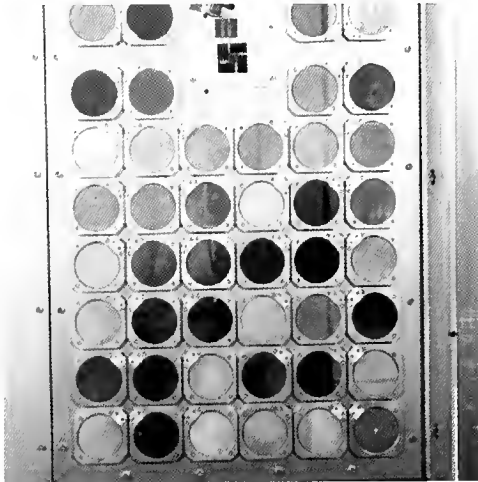
Figure 332
Photo No.: KSC-390C-2070.12
Dup. Neg. No.: L91-10236
LISAR No.: EL-1994-00480
Photo Credit: KSC
Photo Date: 3/19/90
Location: KSC SAEF II
Subject: Postflight Detail of Lower Right of
Tray D6

Figure 332 (Postflight). This photograph is of the lower right one-sixth of the tray. The different colors of the detectors are due to reflections of surrounding areas. Some small impacts on the sensors are visible. There is some discoloration of the mounting hardware and baseplate.

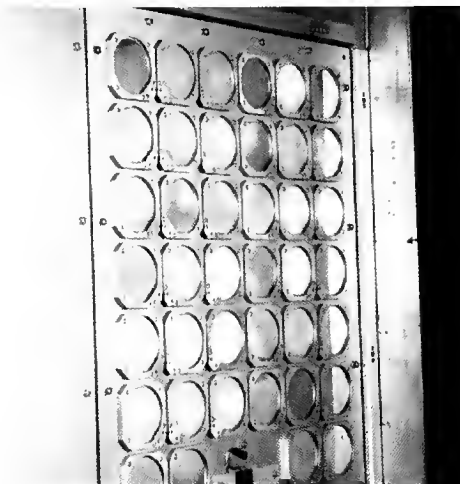
Figure 333
Photo No.: KSC-390C-2071.02
Dup. Neg. No.: L91-10238
LISAR No.: EL-1994-00481
Photo Credit: KSC
Photo Date: 3/19/90
Location: KSC SAEF II
Subject: Postflight Detail of Upper Right of Tray D6

Figure 333 (Postflight). This oblique view photograph is of the upper right one-sixth of the tray. The different colors of the detectors are due to reflections of the surrounding areas. Note the reflection of the tray restraining bar in the surface of the right row of detectors.

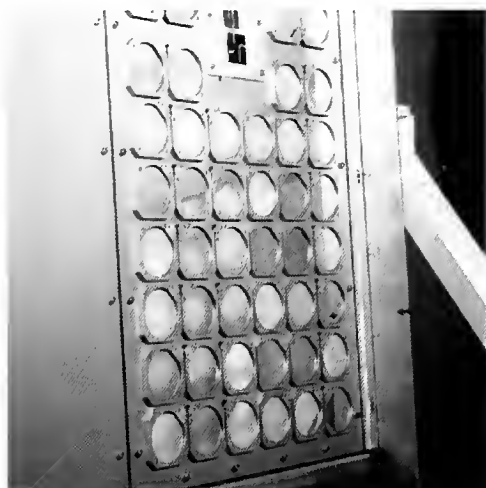
Figure 334 (Postflight). This oblique view photograph is of the lower right one-sixth of the tray. The different colors of the detectors are due to reflections of the surrounding areas. Note the reflection of the tray restraining bar in the surface of the right row of detectors.
